FINAL REPORT

***ACCIDENT TO AN ULTRALIGHT AIRCRAFT
VL-3E-1 EVOLUTION, THAT OCCURRED ON 23
JULY 2022 IN THE AREA OF NIŠIĆI PLATEAU,
BOSNIA AND HERZEGOVINA***

Edition: 1.0
Date: 10 November 2022
Markings: ACCID - 1/22

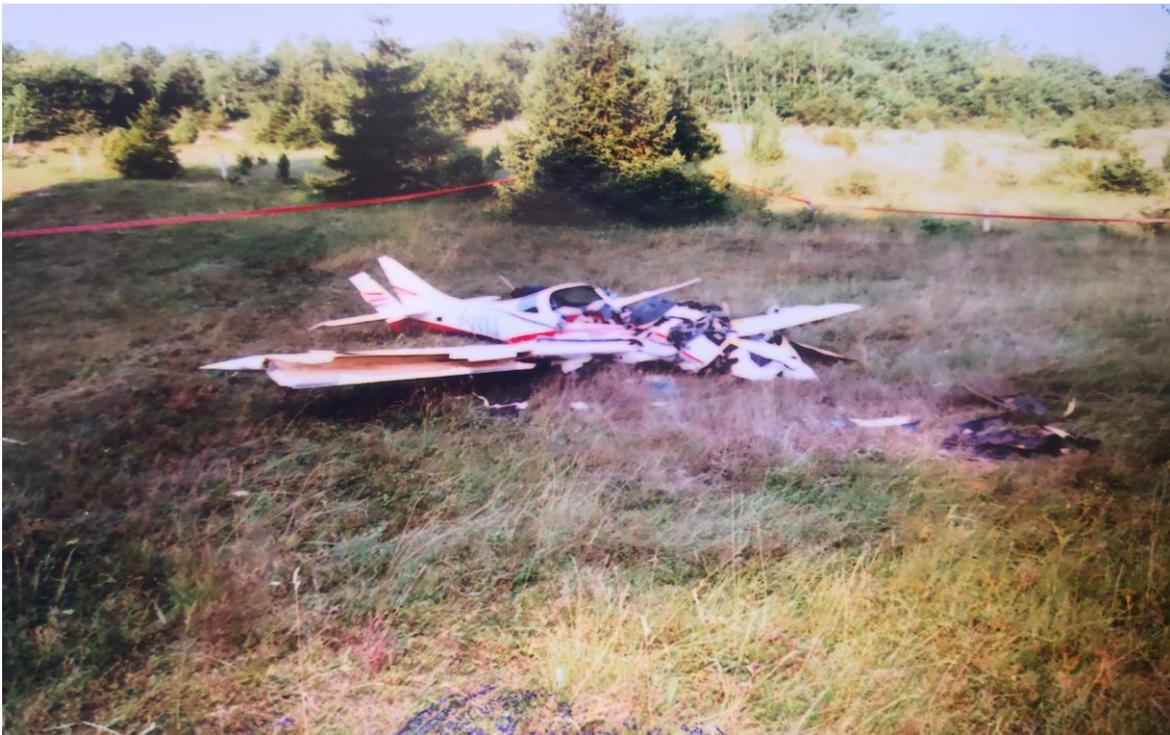
Figure 1.9: The location where the plane hit the ground and stopped

According to eyewitness accounts, the plane suddenly took a left turn at angle and as the angle was gradually increasing the plane first entered into a descending turn and then started to spin at descending angle of 70 while rapidly losing the altitude.

Based on the clues found on the ground at the impact site and the wreckage, it is evident that the plane first hit the ground by its propeller hub, propeller and nose and then by the winglet. Due to the impact force, the plane bounced back for 4,55 meters.

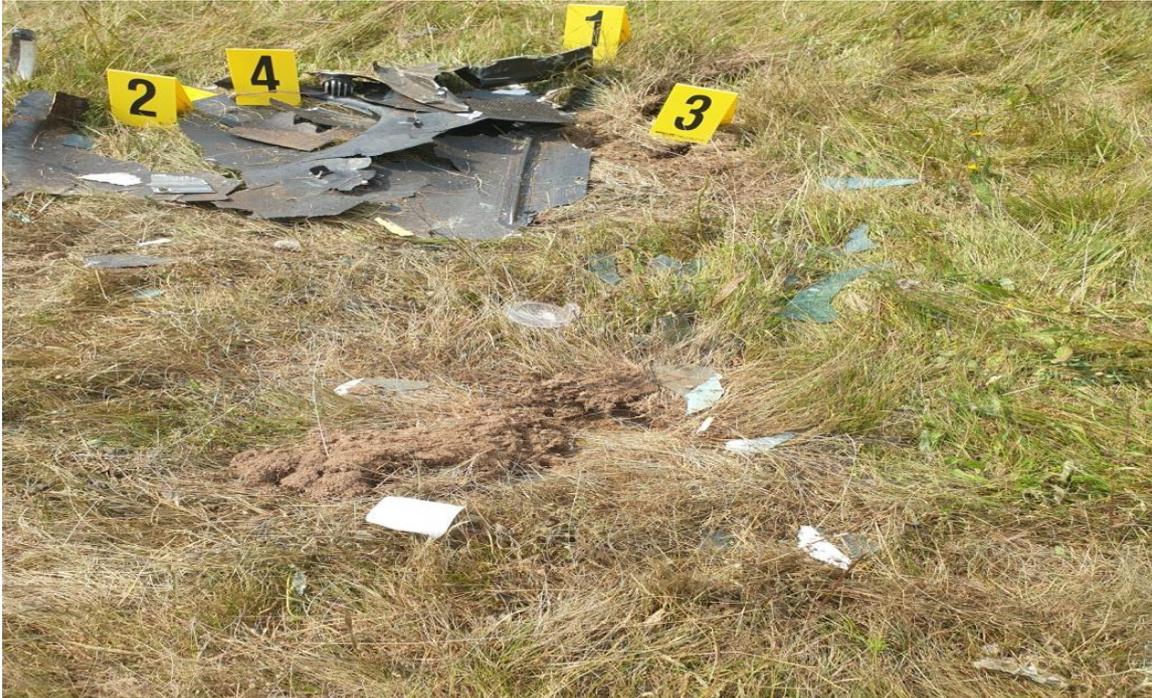
Figure 1.10: First impact into the ground, engine case debris, a propeller blade and parts of plexiglass

The distance between the debris of the plane nose cladding (engine) and the propeller and the detached wing tip on the ground exactly matches their distance when installed on the plane (4.55m). Figure 1.10. and 1.11

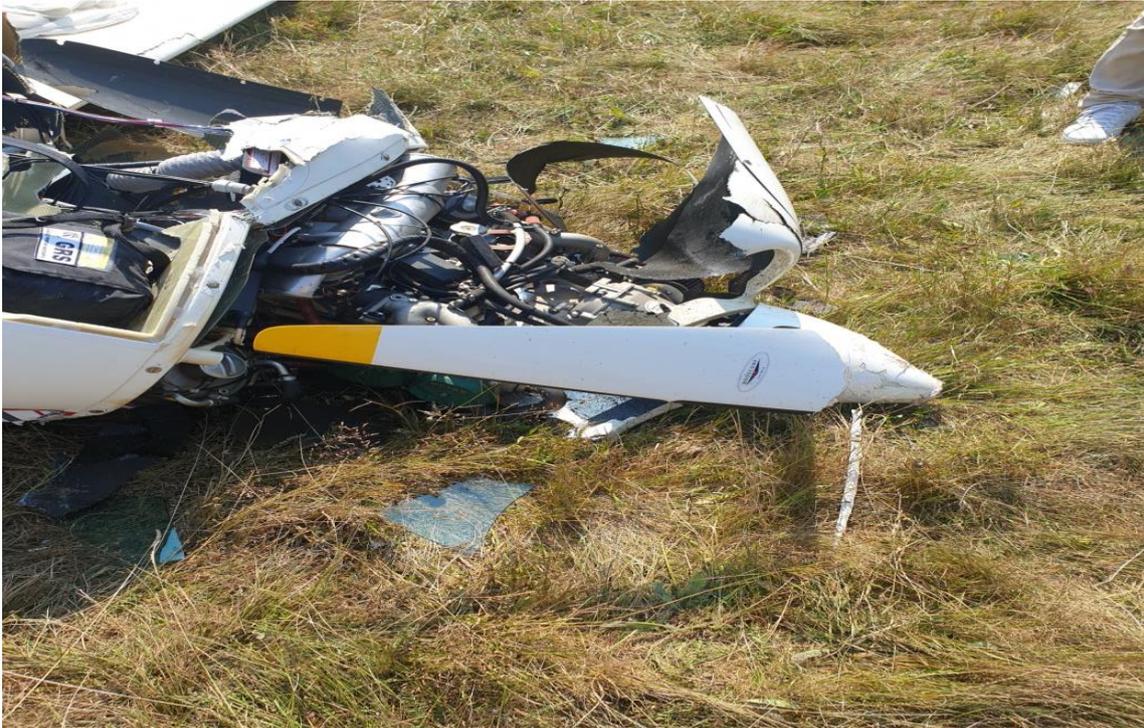
Figure 1.11 Plane's nose, engine, proppeler hub and proppeler blade after the accident

Following the impact, the wreckage due to impact force moved backwards resulting in partial decomposition of some parts of the aircraft. First to fell off were a proppeler blade, plane nose cladding parts and parts of the engine. Most of the fuselage, engine, wings, tail, and cabin suffered considerable damage.

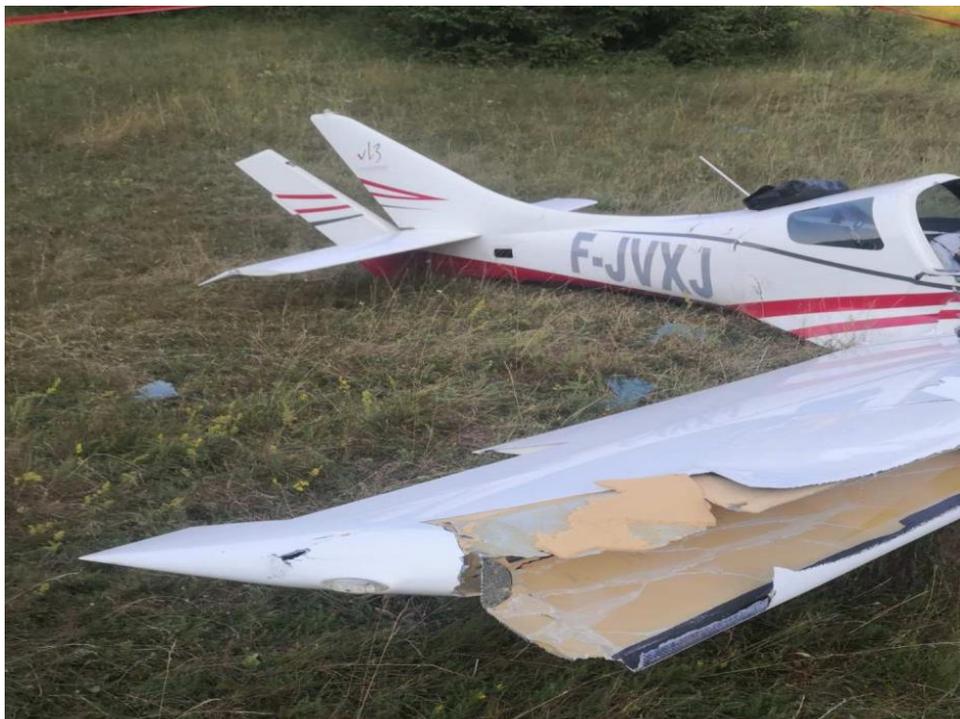
Figure 1.12: Right wing, plain body and tail

The tip of the right wing and the leading edge cladding suffered major damage when the plane hit the ground. Part of the fuselage between the cabin and the tail was badly damaged due to the torsion force once the plane bounced back after hitting the ground. Following the first hit, the plane bounced back for 4.55 meters and then hit the ground for the second time with the whole its weight causing the major damage to the area between the cabin and the tail.

The tail areas also suffered damage. The rudder had separated from the vertical stabilizer. Figure 1.12. Neither gasoline smell nor gasoline leaks was detected on the accident site. Likewise, there was no fire caused by fuel.

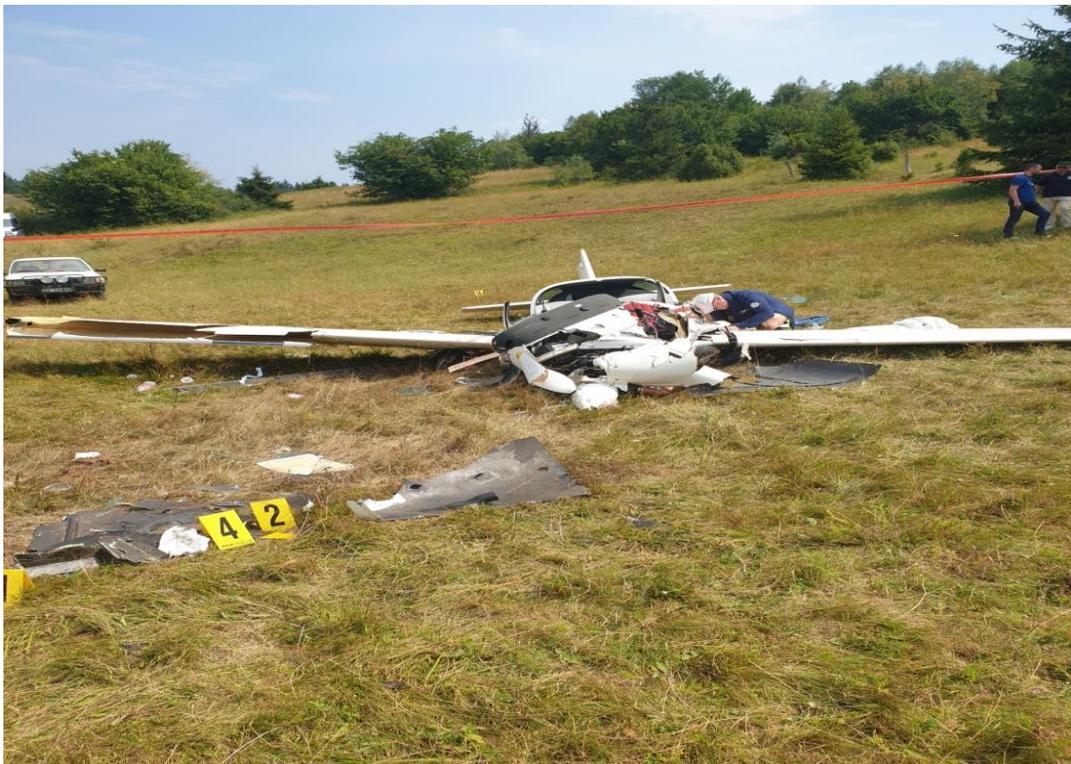
Figure 1.13: Wreckage on the accident site

The fact that the plane parts are scattered in such a narrow space suggests that the plane hit the ground in a steep dive. *Figure 1.13 and 1.14.*

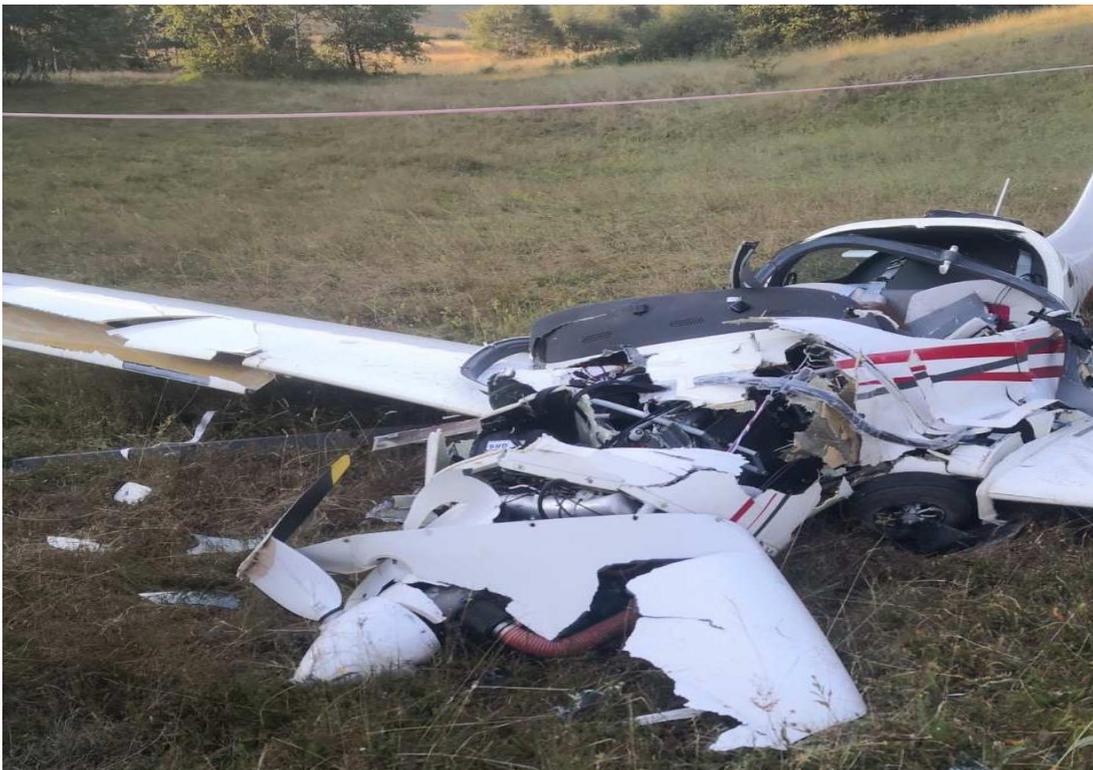
The location of the wreckage is on the coordinates N 44°04'20" E 18°31'01", axis of direction 060°-240°. The wreckage was found to be compact featuring major damage to the main parts of the plane and minor separation of exterior parts. The joints between the fuselage and both wings are found to be loose.

The right wing suffered major damage to the leading edge cladding in the length of about 2 meters starting from the end of the wing, as well as damage to the wing tip (tremizon). The engine, together with the firewall, was also separated from the cabin backward. The cabin canopy was broken and separated from the cabin. One blade of the propeller was completely torn away while the other was broken and bended straight backward at angle of 90°. This suggests that the propeller was not spinning at the time of impact. A part of the fuselage located behind the cabin was damaged. There was minor twisting of the fuselage structure. Tips of the vertical stabilizer got detached on impact. One is located adjacent to the fuselage and the other is five meters behind the wreckage. The rudder is separated backwards from the vertical tail stabilizer.

Figure 1.13: The wreckage at the accident site

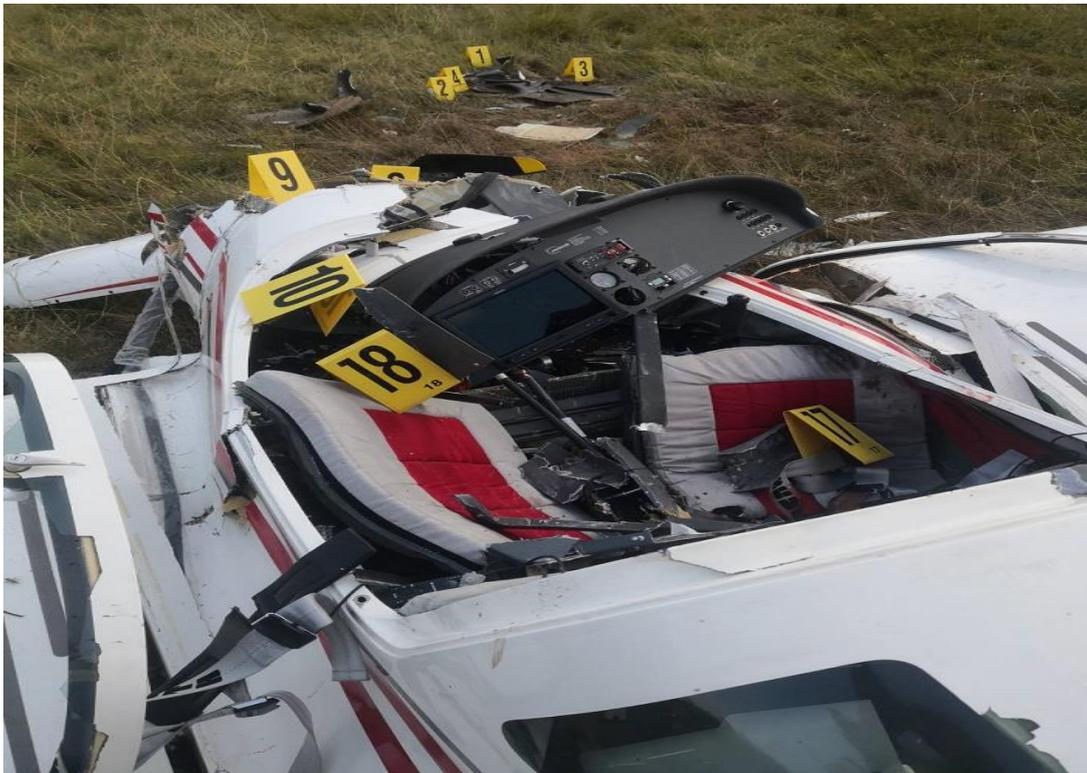
The body of the passenger at the right-side seat remained in place, moved to the side, with the seat belt fastened. The body of the pilot was positioned adjacent to the left side of the fuselage on its back with the head facing the plane nose. The safety belt was ripped out from the anchorage together with a bolt and part of the composite. The body of the pilot went through the canopy of the cabin and then

was pulled back by the safety belt strings which caused for the safety belt anchorage to be ripped out.

Figure 1.14: Plane cabin and torn pilot seatbelts
