FINAL REPORT

***ACCIDENT TO AN ULTRALIGHT AIRCRAFT
VL-3E-1 EVOLUTION, THAT OCCURRED ON 23
JULY 2022 IN THE AREA OF NIŠIĆI PLATEAU,
BOSNIA AND HERZEGOVINA***

Edition: 1.0
Date: 10 November 2022
Markings: ACCID - 1/22

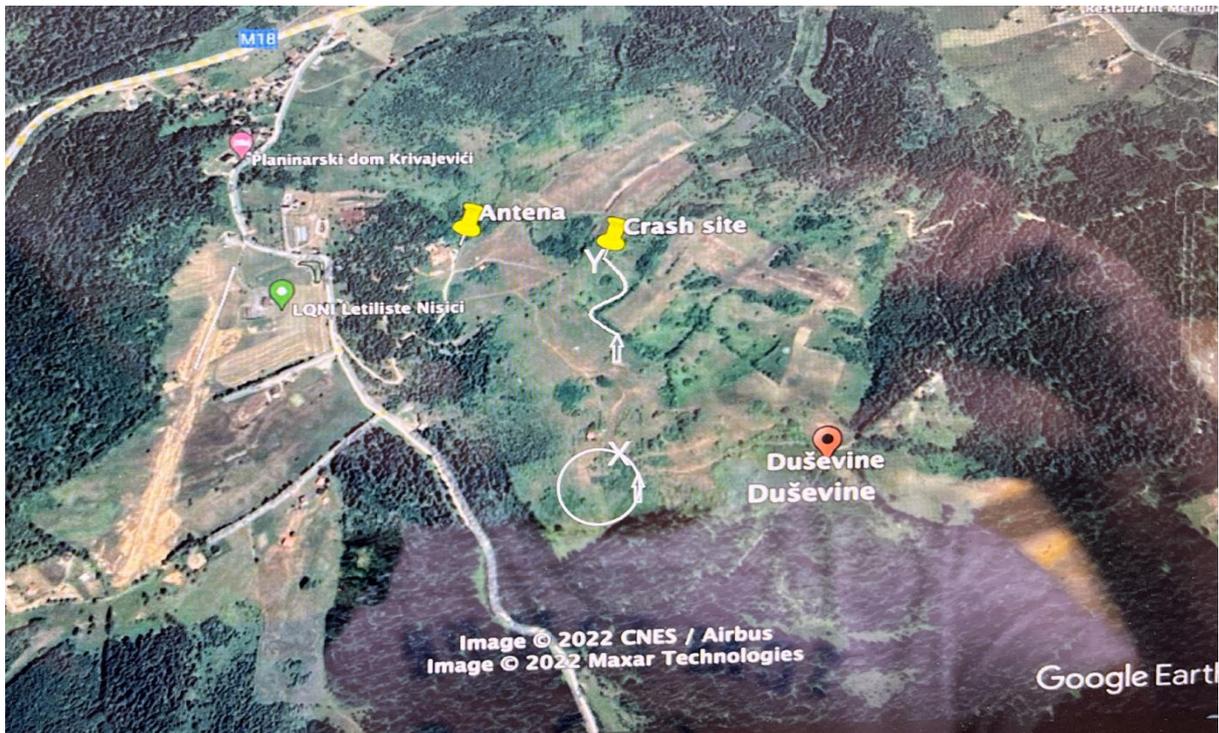
Image 1.1: Position of eyewitnesses of the accident from the air

" On 23 July 2022 around 15:00 LT, I was conducting a flight with aircraft HU-UAL (ultralight aircraft, type STING) near LQNI airport. I was in position "X" in holding, and

circling in left turn, at altitude approx. 250 meters. I saw ultralight aircraft, type VL-3E in position "Y", performing „S" at altitude between 50-100 meters above the terrain. And in one moment wings slightly turned to the left and then to the right, toward the ground in the right reel. All this lasted 2-3 seconds. I am not sure, but the aircraft made some 2,5 turns to the right side until it reached the ground. On the radio communication I heard the pilot saying "Aj, aj, aj" before the aircraft hit the ground. As I can recall the aircraft hit the ground with the nose, but I am not completely sure, because I was busy operating my aircraft". Image No. 1.1.

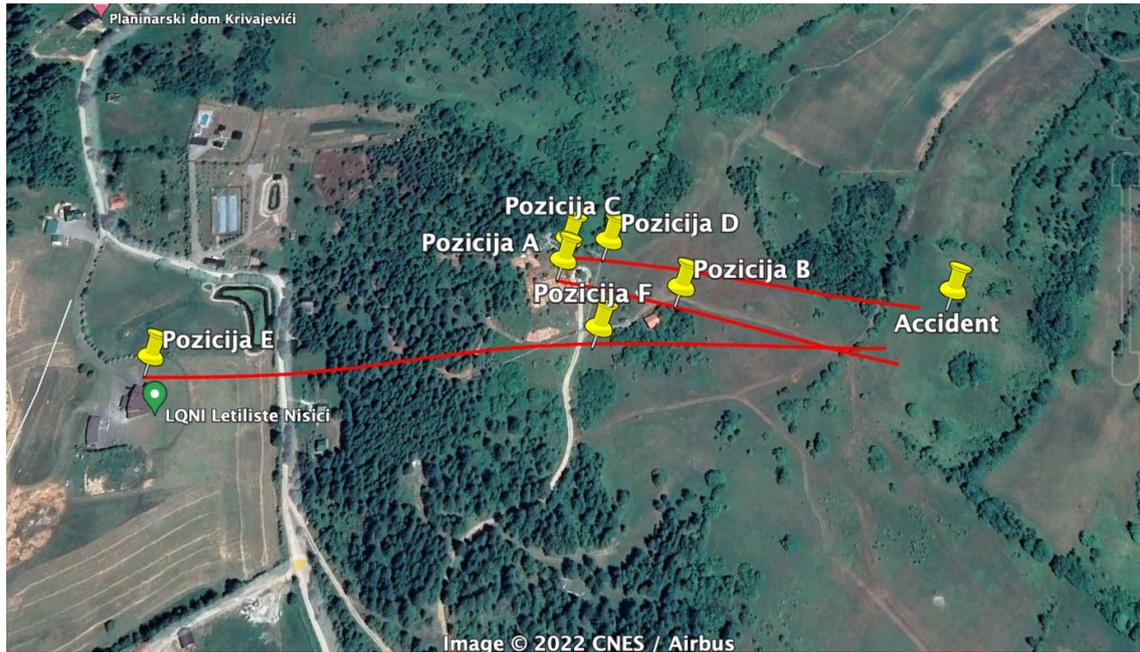
Image 1.2: Positions of eyewitnesses of the accident

Part of the statement of gyrocopter pilot in the position „E" (on the ground) at Nišići airport: "After the aircraft flew near the antennas, after some 50 meters, it suddenly banked in the left tailspin with left rotation and in one moment it was directed to the ground while the cockpit was directed toward me. It disappeared beyond the horizon,, Image No. 1.2.

There were several eyewitnesses in position „C". All of them stated that they saw aircraft making left turn which looked like stunt and then it went out of sight vertically downwards. After that they heard loud impact. They stated that they did not hear sound of aircraft motor.

In position „C" were located eyewitnesses of the accident and persons that first came to the accident site and alerted police and ambulance. Image No. 1.2.

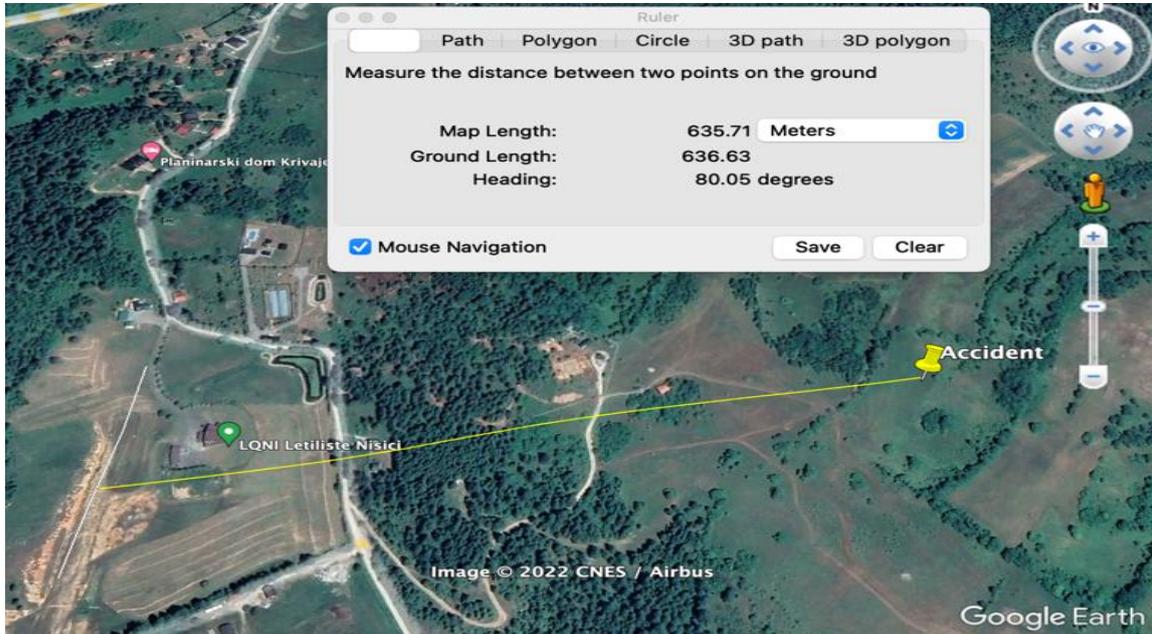
Figure 1.7: Plane accident site

Accident site coordinates: 44°04'20" N and 018°31'01" E, elevation of the terrain 992 m / 3255 ft. The accident site is located approximately 650 meters, course 080°, east of RWy Nišići airport. *Figures 1.7 and 1.8*

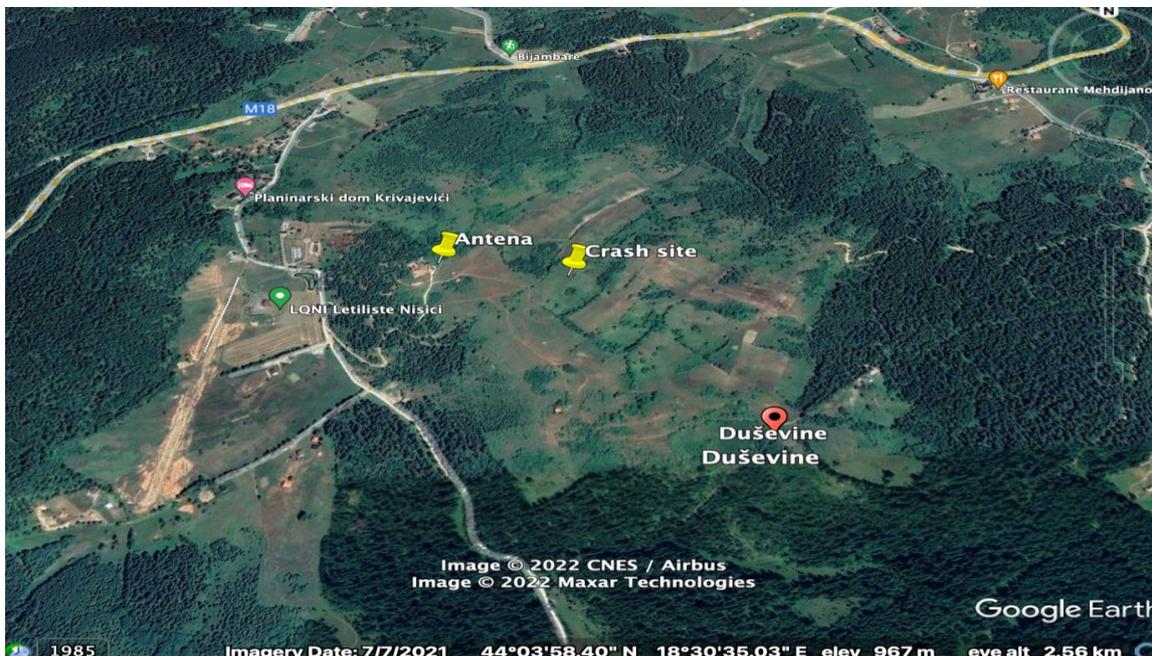
Figure 1.8: The plane accident site

The plane accident site is located on a scarcely populated hilly terrain partly covered with forest consisting of mainly coniferous 12-20 meters high trees as well as smaller ones of 3 to 5 meters in height. The terrain surrounding the accident location has a gentle upward slope in all directions. There is a local forest road

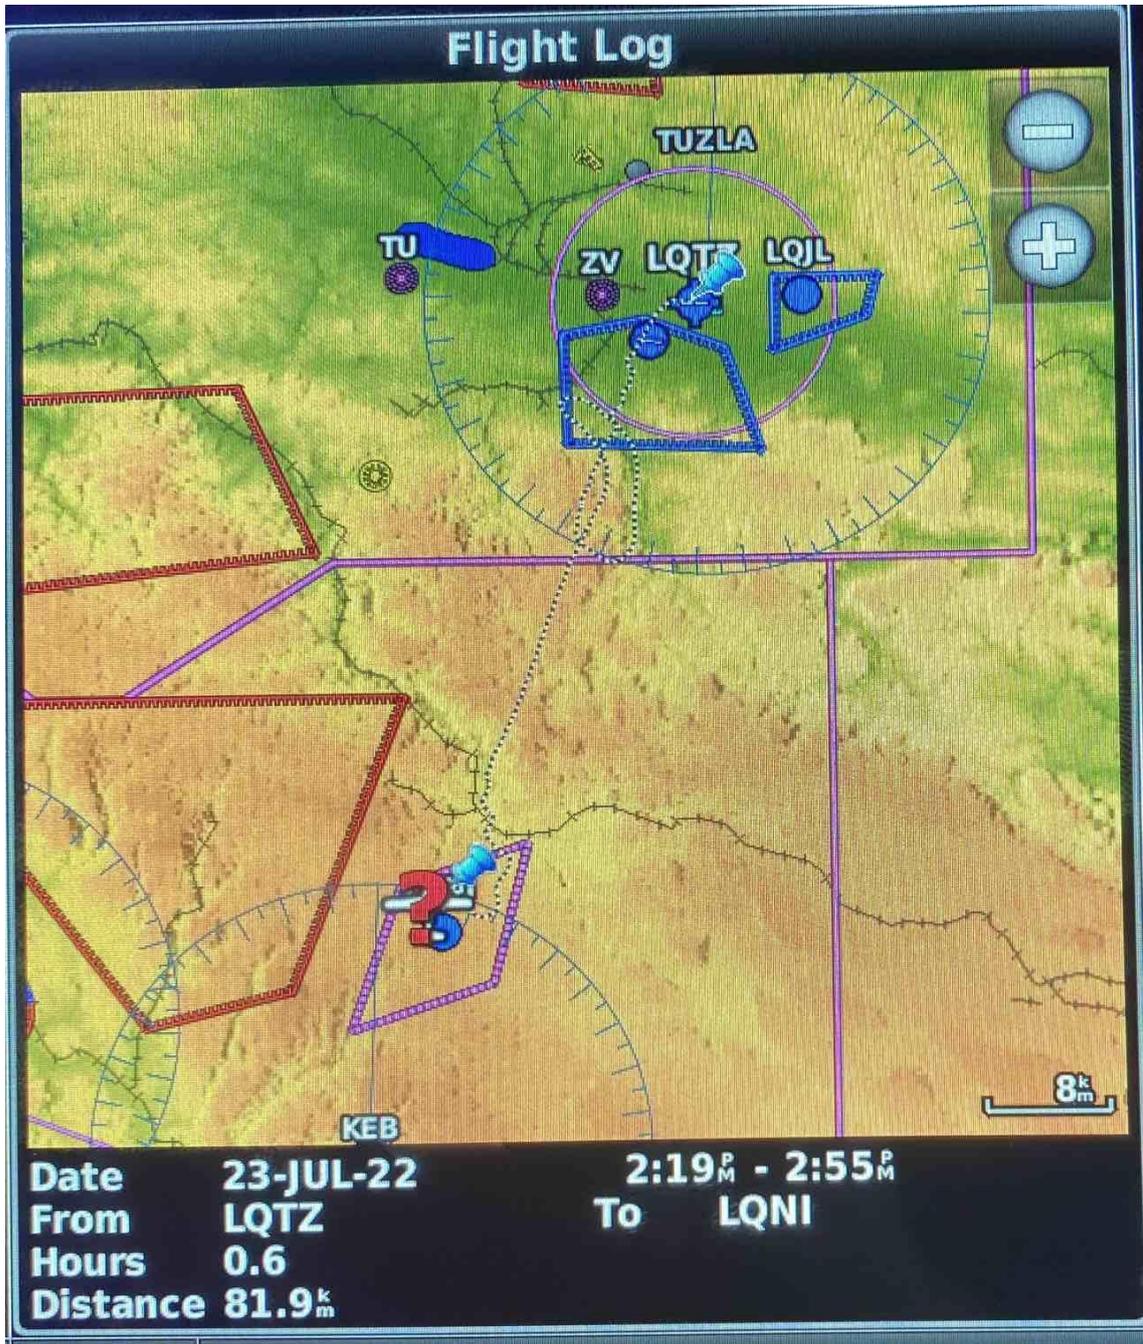
Figure no. 2.3 : Aircraft flight from the Tuzla Airport (LQTZ) to the Nišići Airport (LQNI)

According to flight data from the Garmin GDU 460 device that removed from the aircraft on July 23, 2022, the flight path from Tuzla Airport to the accident site is shown in *Figure*.

The aircraft VI-3E took off from Tuzla Airport (LQTZ) at 12:28 UTC. After the take-off, the flight continued along the route according to the flight plan towards the Nišići Airport (LQNI). After the left turn in the direction of Đurđevik, the aircraft moved along a rather unstable path in the climb. At 12:33 UTC, at an altitude of approx. 4300ft AMSL, the aircraft made a left turn at 1800, back towards Đurđevik and descended to 1700ft AMSL.
